The owners were very unhappy with many items in their old kitchen. The kitchen was way too small for their family. It had insufficient storage, poor lighting, unsafe traffic flow and was very cramped to work in.

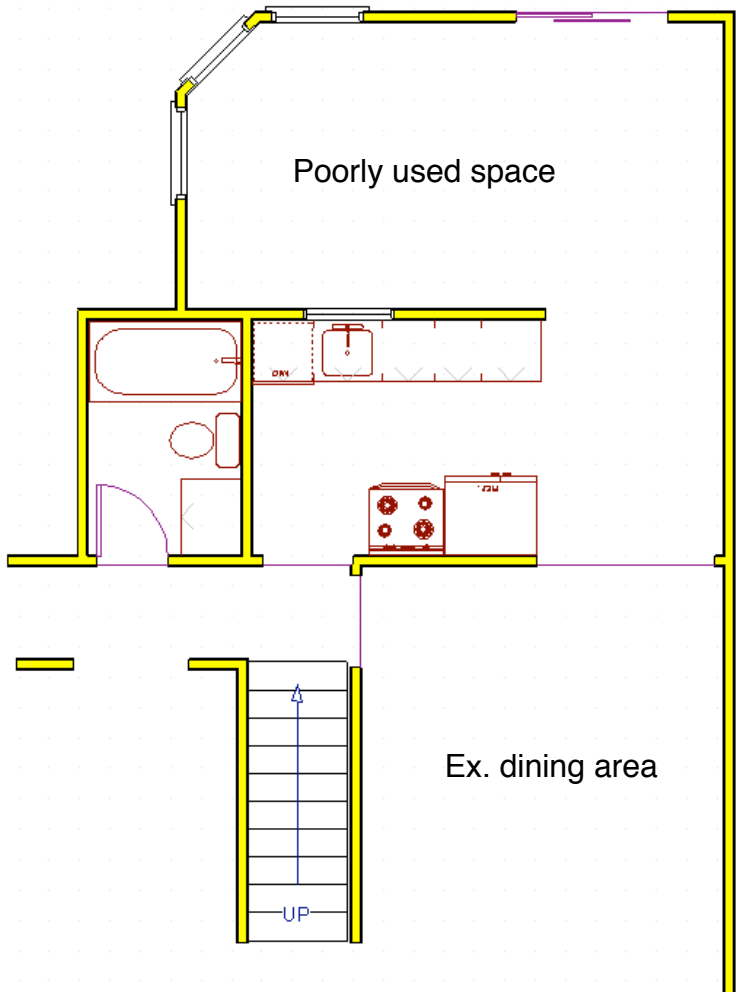
Before

Poor and unsafe traffic patterns created by the corridor kitchen and into the rear dining area.

Insufficient counter area.

Insufficient cabinetry.

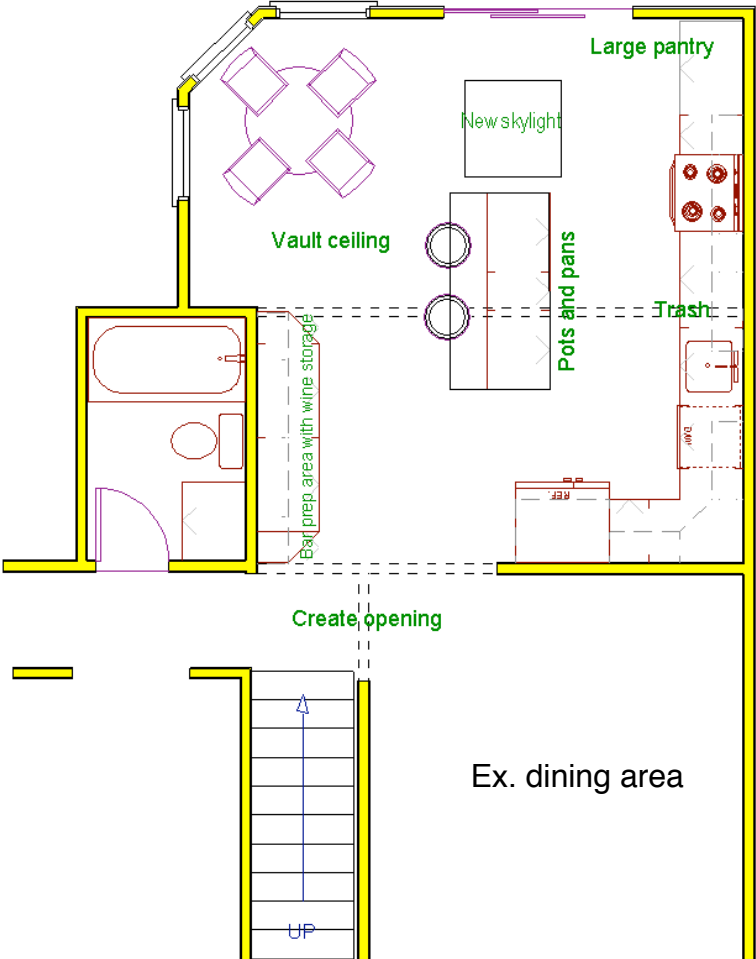
After

Traffic pattern is now safe and improved by the new opening. It does not interfere with the work triangle.

The new opening also keeps the front dining area separate from the kitchen, as the homeowner requested.

New layout keeps bar prep area easily accessible for dining area and entertaining guests.

Island has required space all around.

Ample cabinetry, drawers, storage, and counter areas are provided for the kitchen.

Vaulted ceiling and skylight adds additional natural light.

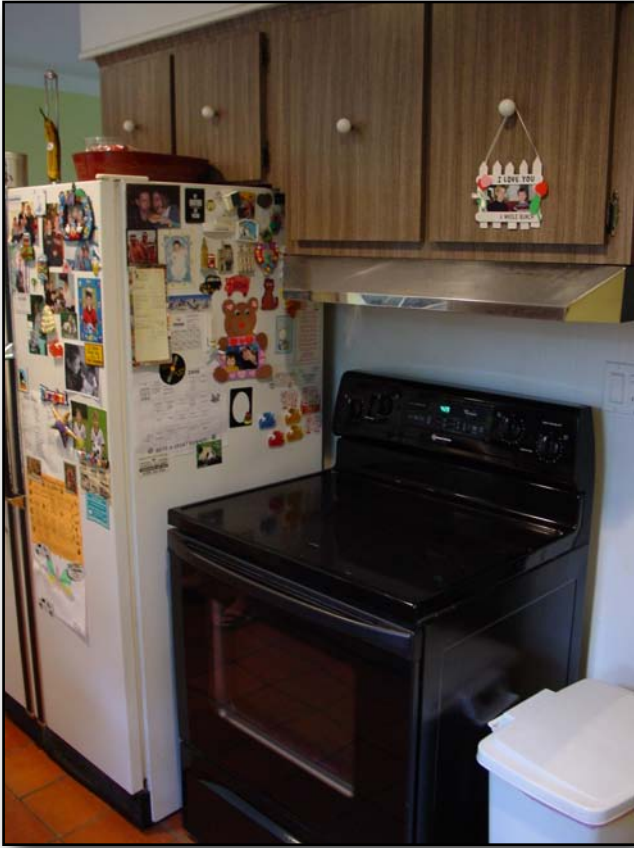
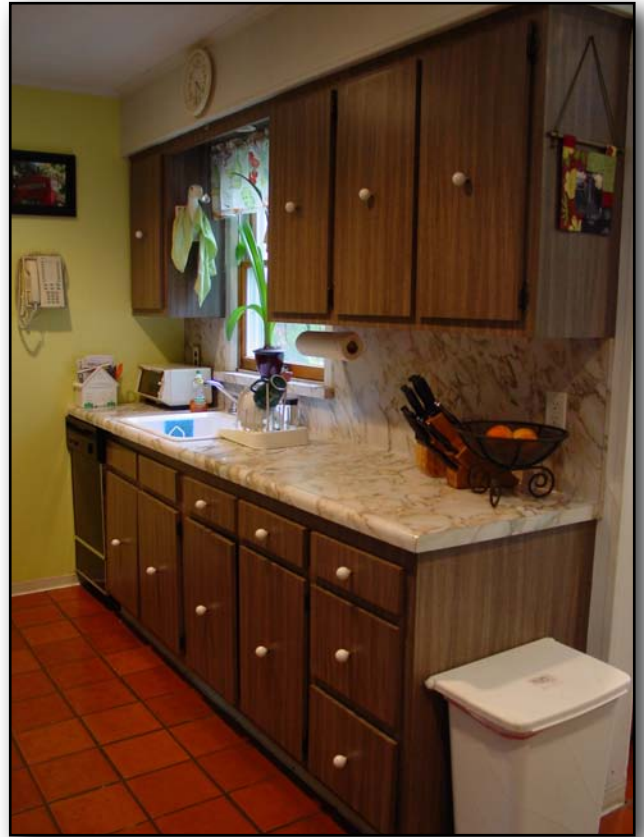
Old unsafe kitchen with minimal storage and counter area.

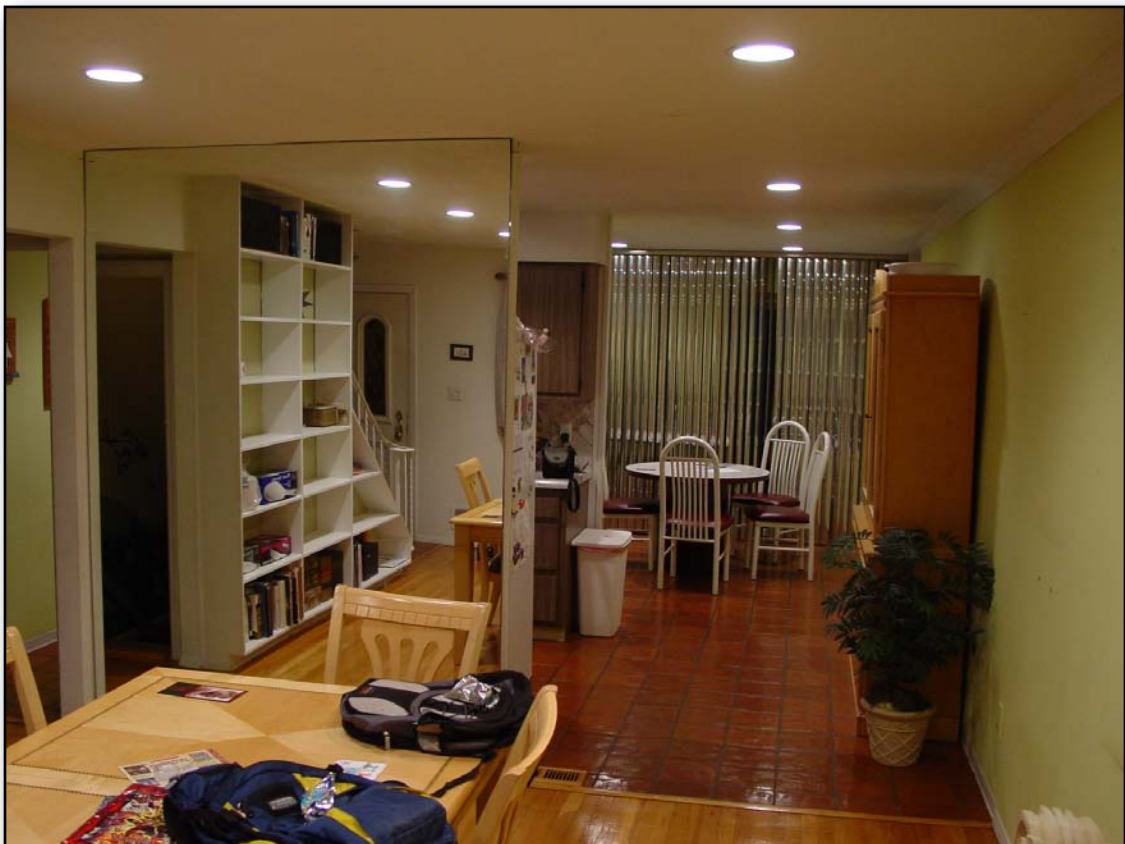
Previous traffic flow to the rear addition with the mirrored wall in the middle.

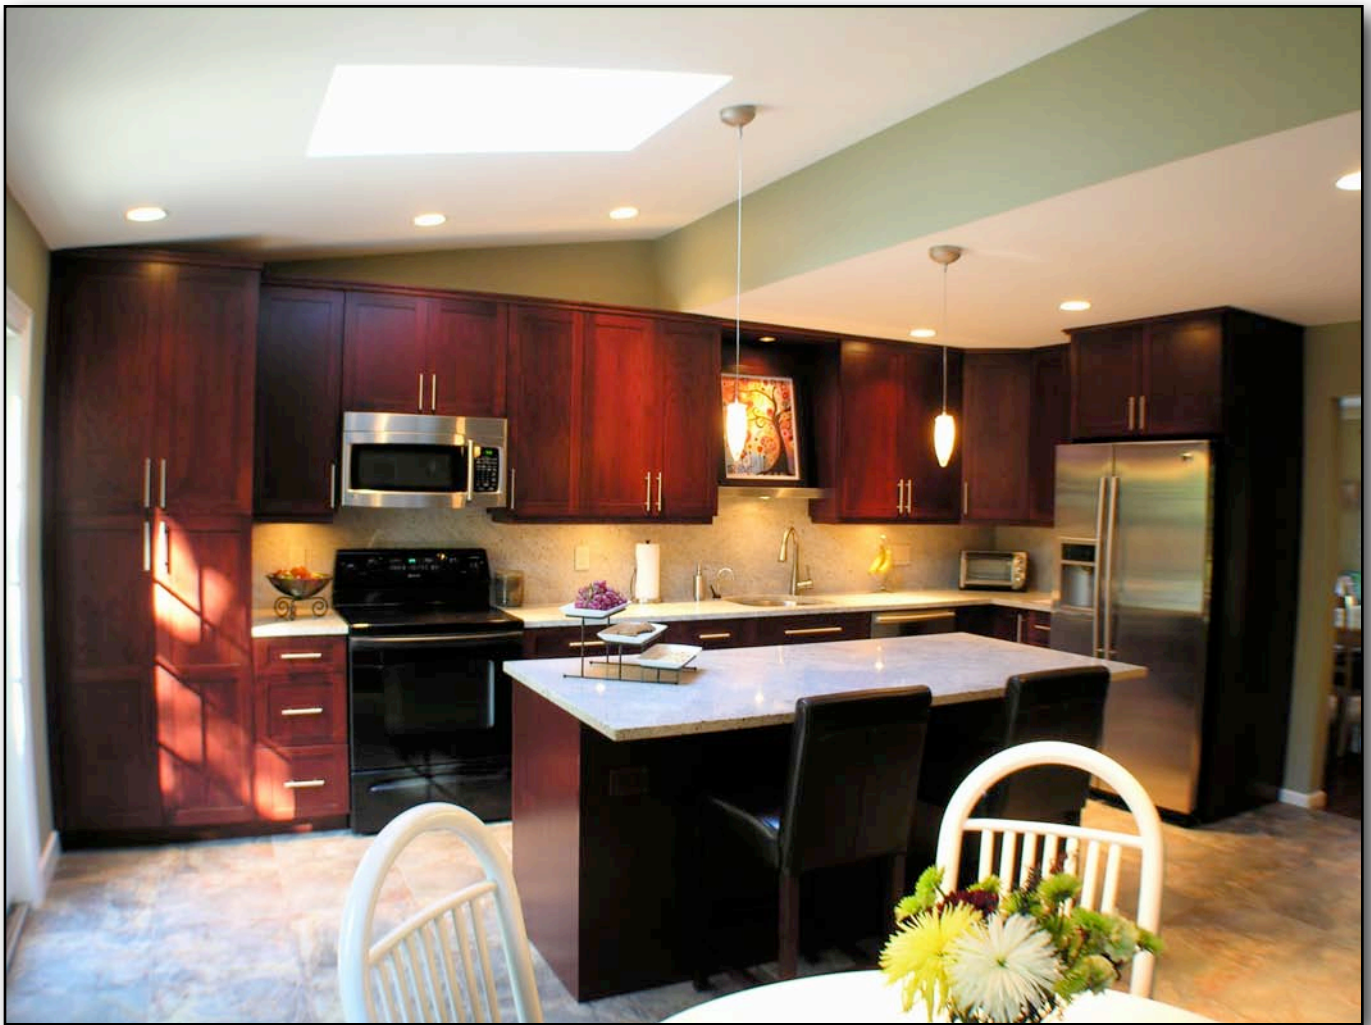
New kitchen with ample storage and counter area.

- 2) By vaulting the ceiling and adding a skylight we were able to add volume to the space and allow more natural light into the new kitchen area.
- 3) The cabinetry was installed to the ceiling to provide more storage space. Drawer bases were used by the refrigerator, stove, and in the island to provide plenty of drawer storage. There is generous counter area for work and landing purposes by the stove, sink, and refrigerator. Additional counter area is provided by the island. The aisle ways around the island have adequate room for safely functioning in the work triangle, without interference from any traffic pattern.

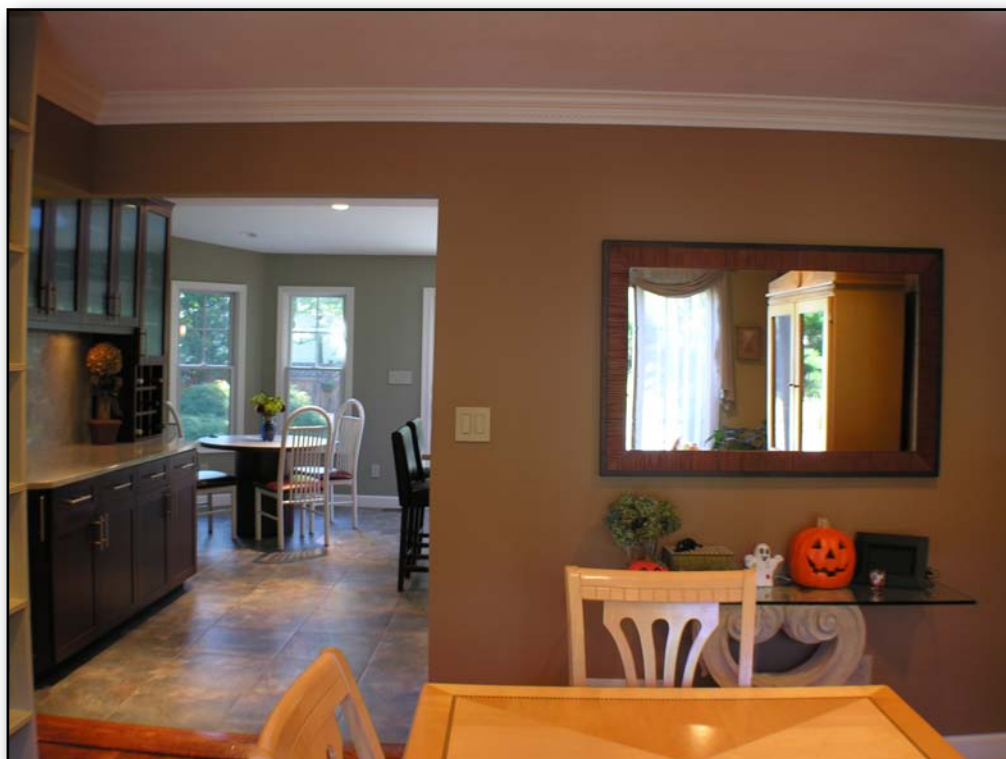
New traffic pattern with wider entry from hallway on the left. Note that the bar prep area is located right next to dining area for easy entertaining.

- 6) The bar prep area was positioned so it can be very accessible while entertaining in either the kitchen or dining area. The obscure glass doors provide a nice contemporary visual touch and allow exposing the contents while still giving protection for them. There is ample counter area for use on any occasion. The wine storage on the ends were custom made with a square box theme to compliment the modern design. They are located underneath the hanging wall cabinets so as not to interfere with any storage.

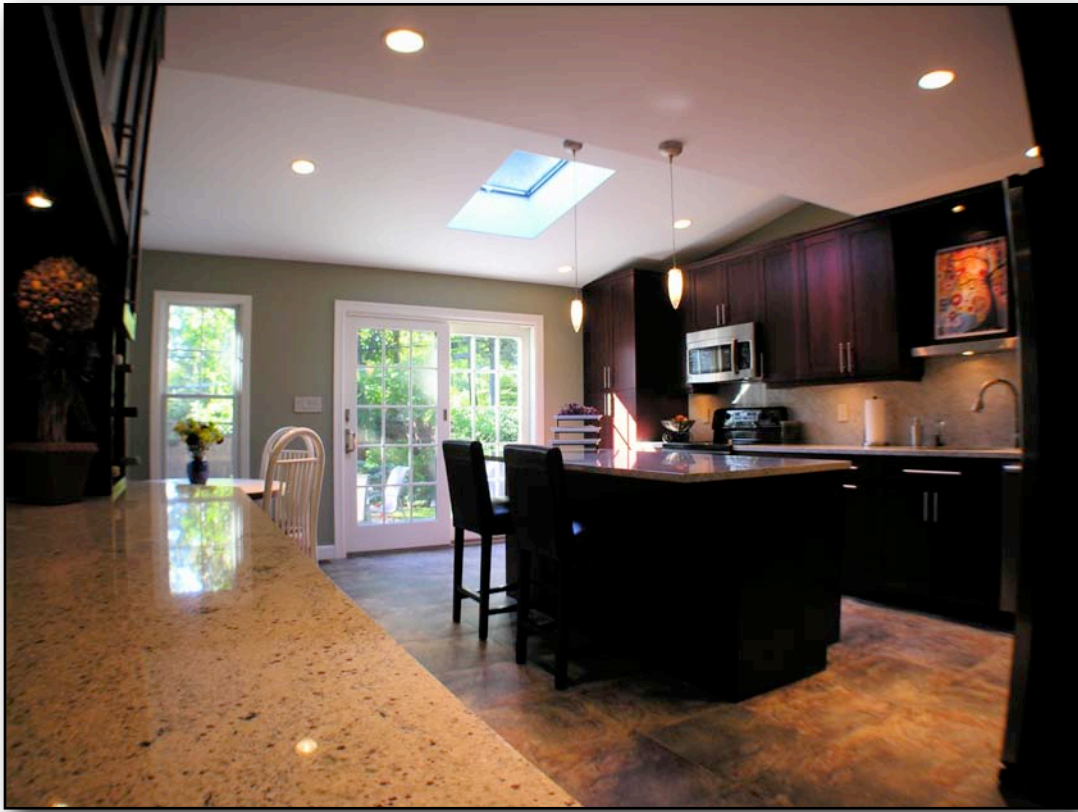
Vaulted ceiling with skylight creating volume and natural lighting.

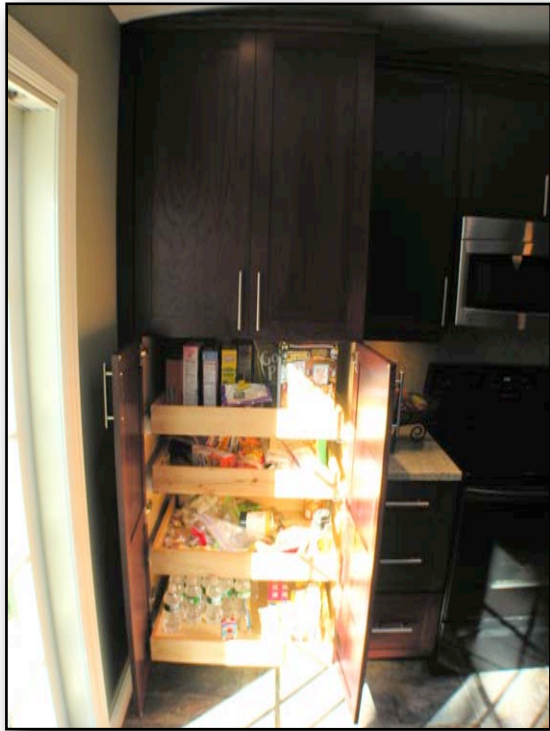
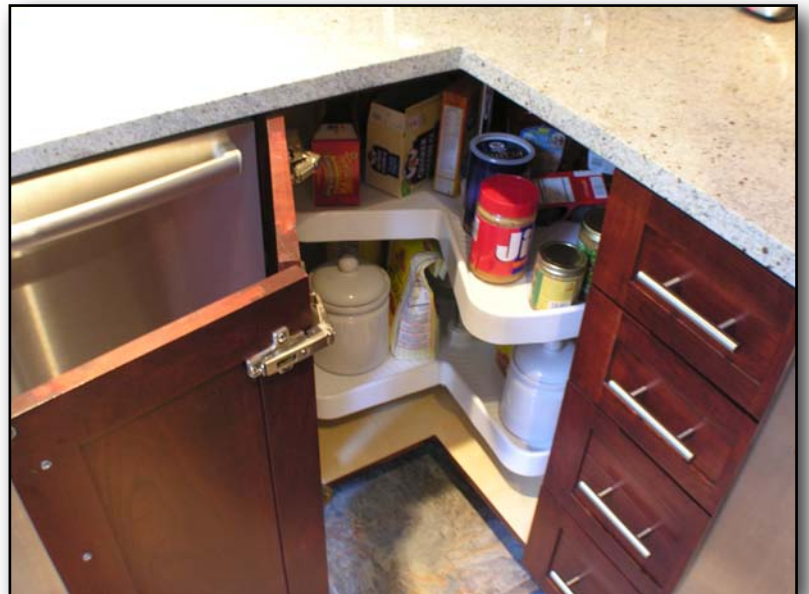
Ample storage options, with large pantry with slide out shelving, easy accessible corner lazy susan, and drawer bases.

- 4) A large pantry was provided with adjustable roll out trays for additional storage and easy access.
- 5) The island is big enough to seat 4 people, plenty of room for the owners children to use. The island also provides two cabinets with slide out trays for ample pot and pan use. A slide out trash was provided by the sink area. The island also provides more counter top landing area for the refrigerator.

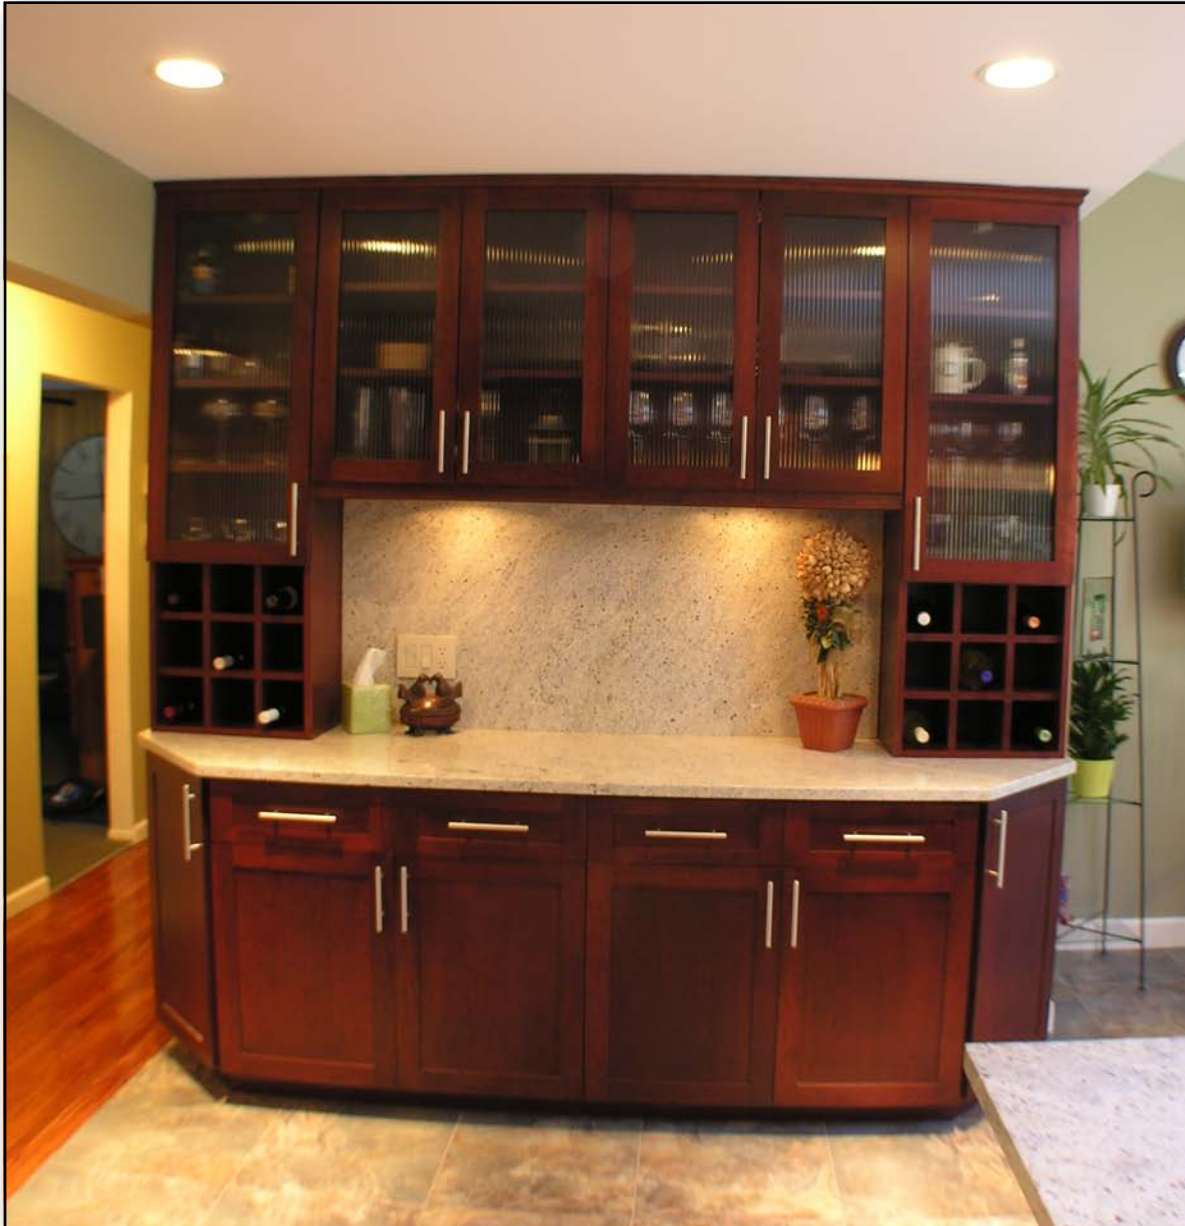
Bar prep area has plenty of storage and usable counter area.

The obscure glass doors show off the glassware.

Wine bottles are neatly contained in the storage boxes while not using cabinet space.

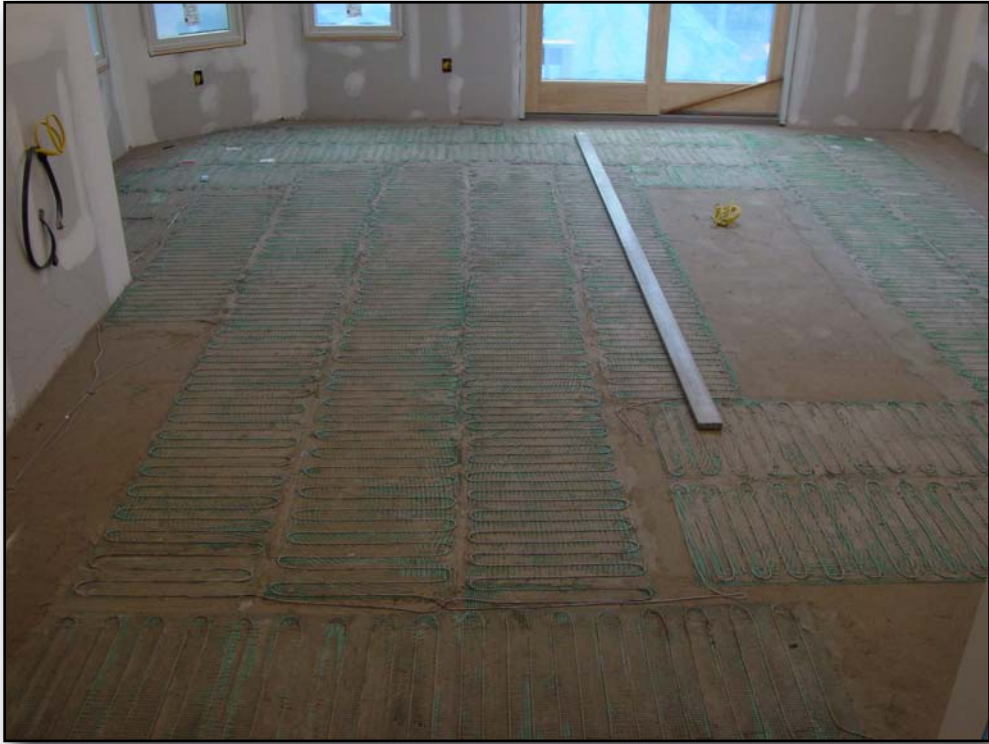
Electric radiant heat and porcelain floor install.

- 7) Task lighting was provided through out the kitchen with the use of under cabinet lighting, a light over the sink, and pendant lights over the island. General lighting is accomplished with recessed ceiling lights. A decorative light was also used for the art work over the sink area.
- 8) Electric radiant heat was used in the kitchen to provide adequate heat for the new area, as well as to provide an energy savings for the owner.
- 9) The porcelain flooring has a durable easily cleanable surface and provides a great conductor for the radiant heat.
- 10) The new layout, while providing a better traffic pattern from around the house, also keeps the formal dining area separate from the kitchen as the owners desired.
- 11) There is also room for a four person table located in the corner of the room by three windows to let in natural light.

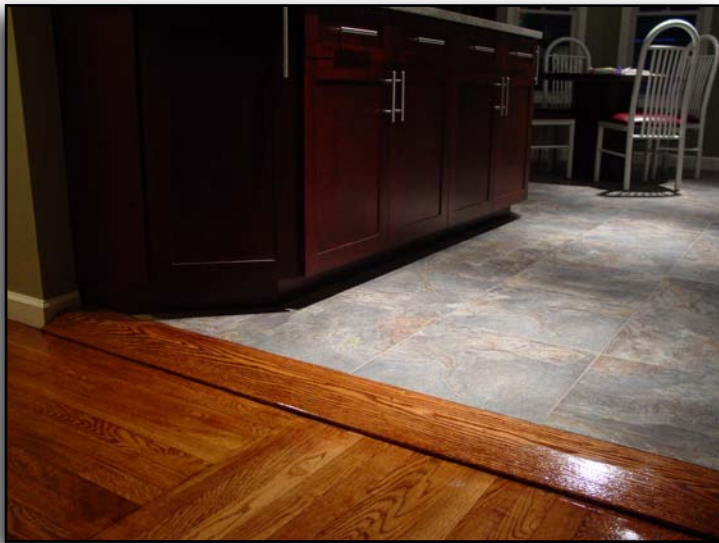
Custom wood saddle.

- The transition from existing flooring to a new tile floor installed in a “mud job” is always a little tricky. We solve this by fashioning a custom wood saddle.
- Upon demolition, it was also discovered that a previous contractor had incorrectly run plumbing lines and cut into the floor beams above the kitchen. We corrected the issue by framing, tecoing, and resting new sistered joists on our new headers.

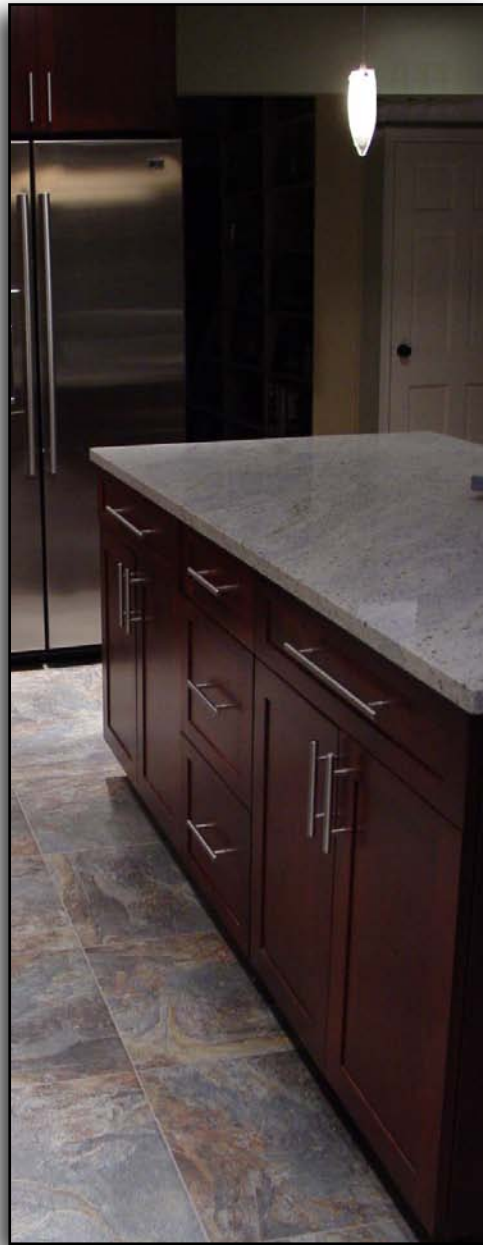
Island storage with drawer base.

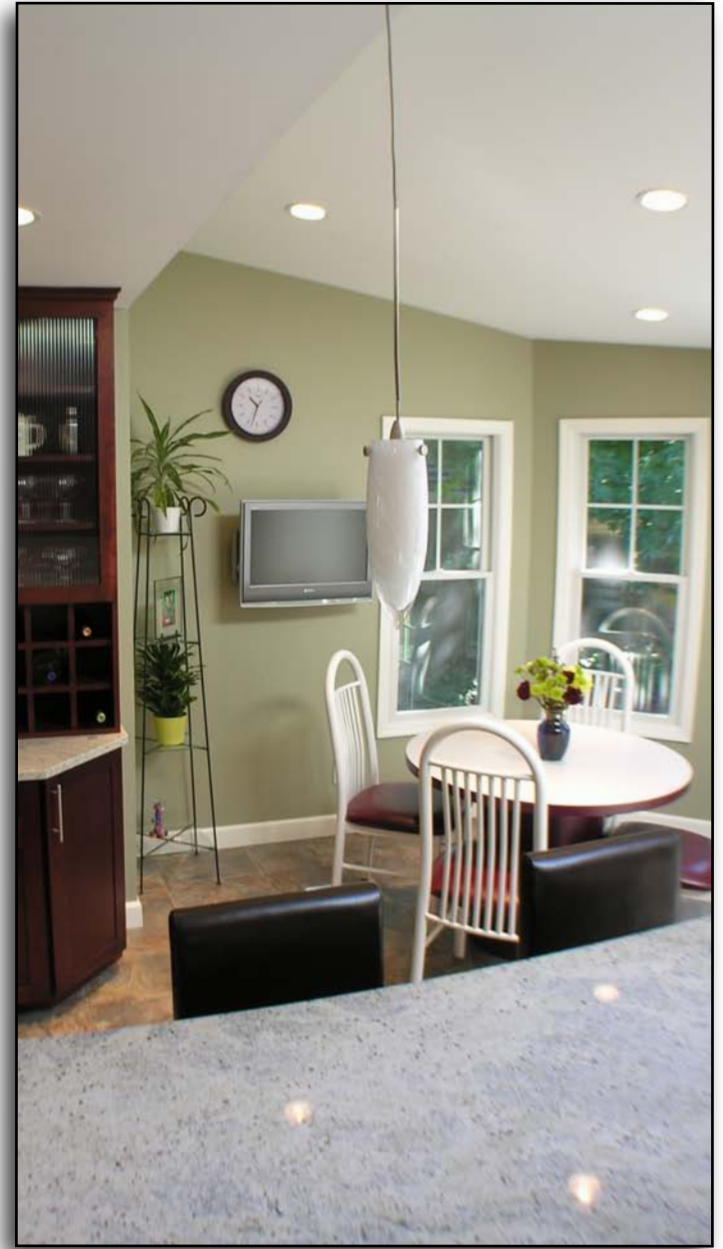
Table area by windows with tv.
